# **Arborist Report** & **Tree Inventory**

Proposed Sierra Gateway Apartments

Rocklin, California

October 19, 2016

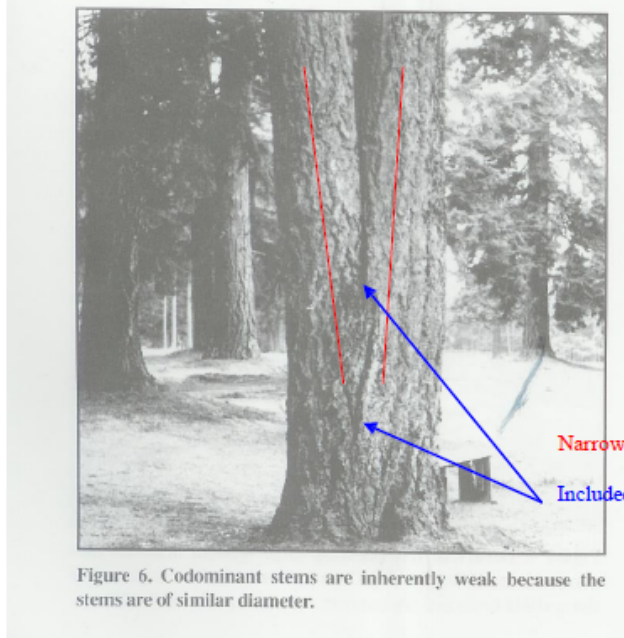
The tree in this picture has a co-dominant leader at about 3' and included bark up to 7 or 8'. Included bark occurs when two or more limbs have a narrow angle of attachment resulting in bark between the stems – instead of cell to cell structure. This is considered a critical defect in trees and is the cause of many failures.

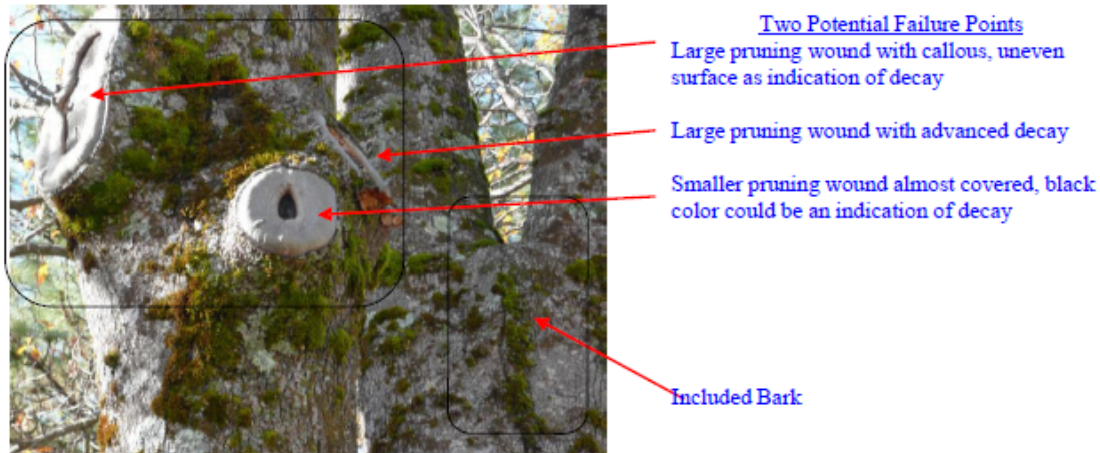
wound, will 'cover it' with callus tissue. Large, old pruning wounds with advanced decay are a likely failure point.
