CLOVER VALLEY

LARGE AND SMALL LOT TENTATIVE SUBDIVISION MAPS

RECIRCULATED DRAFT ENVIRONMENTAL IMPACT REPORT

PREPARED FOR
THE CITY OF ROCKLIN

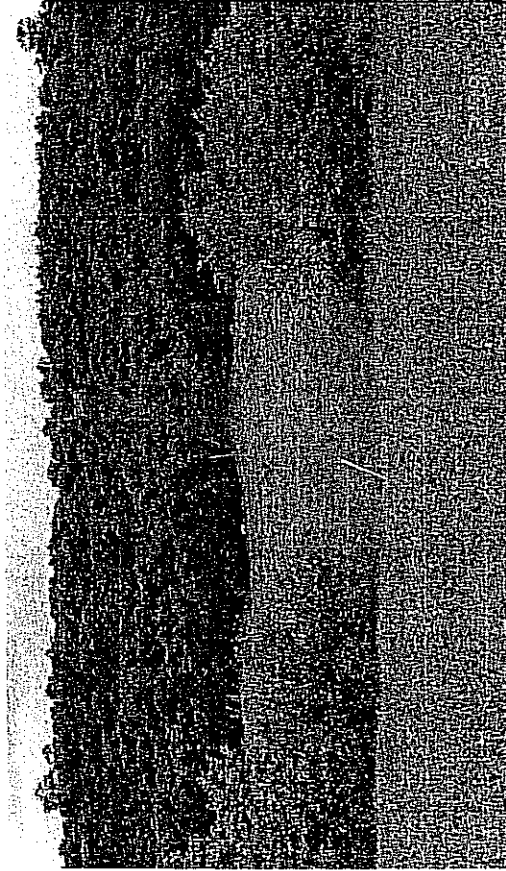
Westerly view of the PCWA water pipeline easement.

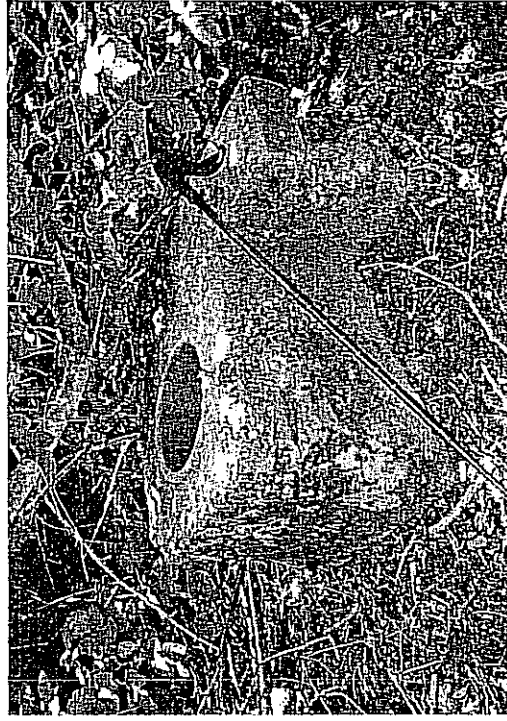
View of the vertical clay pipe and concrete foundation located near the northerly property boundary.
